**Real Estate
Appraisal
Report**

Optimum Outlet Shopping Center and Plot

Yüreğir / Adana

2023REVB454 / 31.12.2023

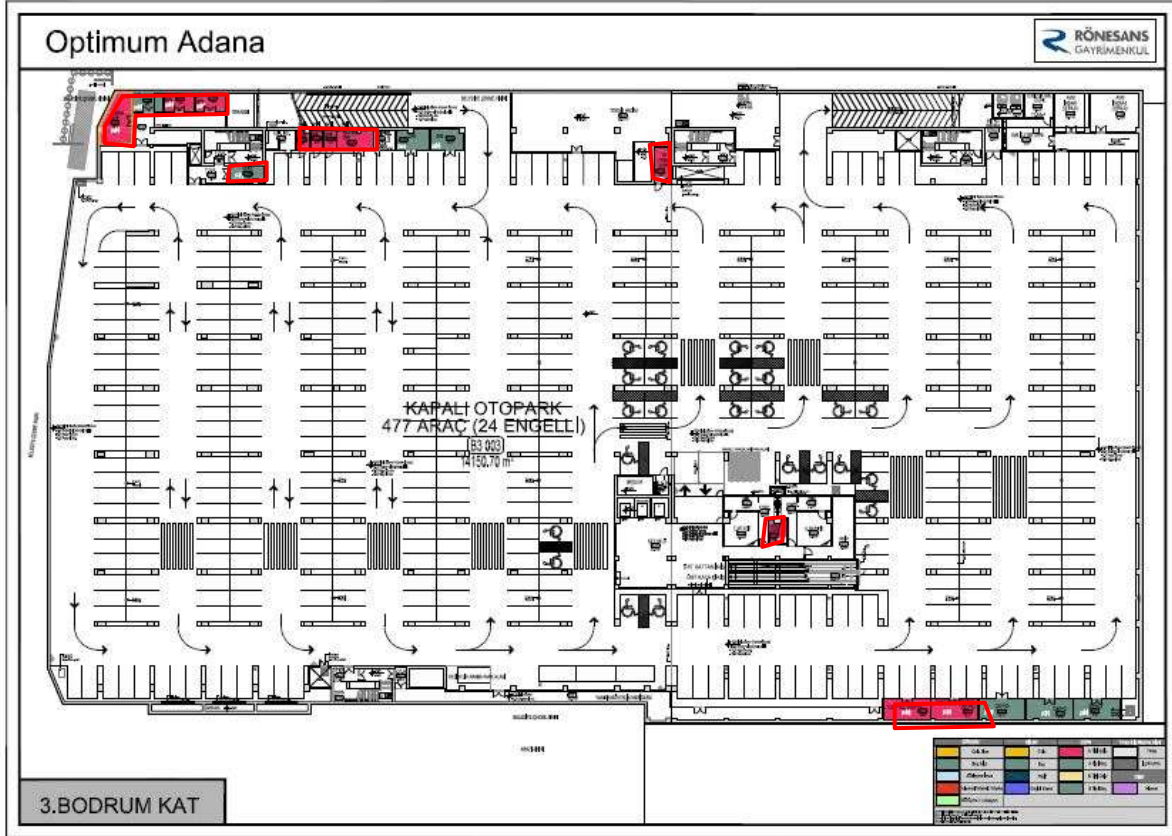
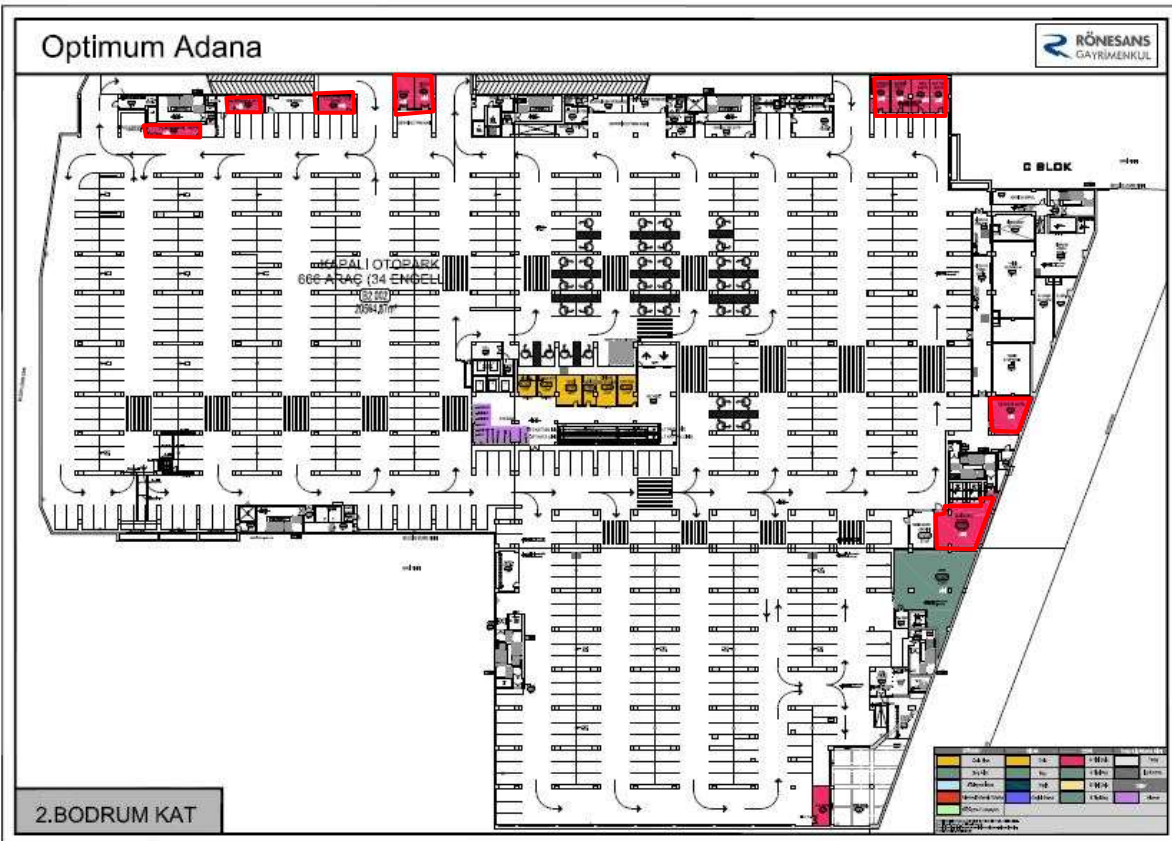
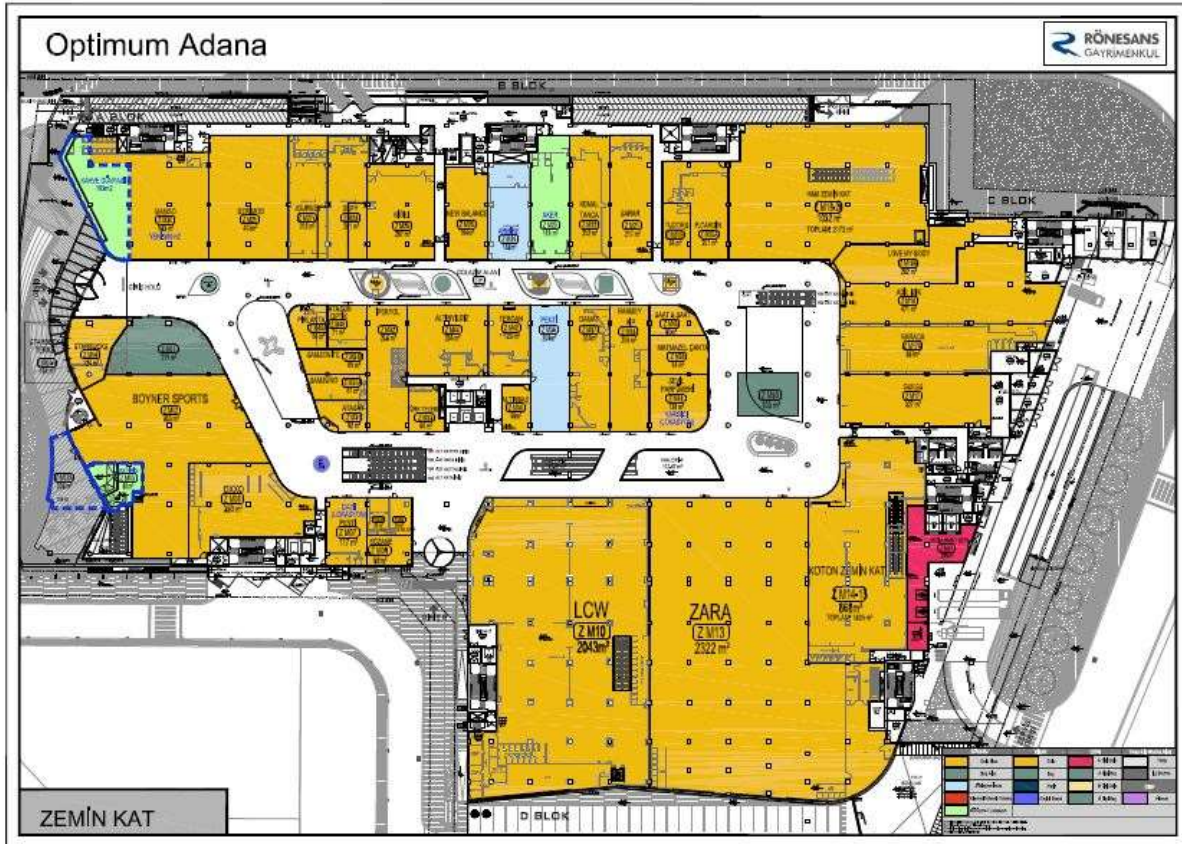
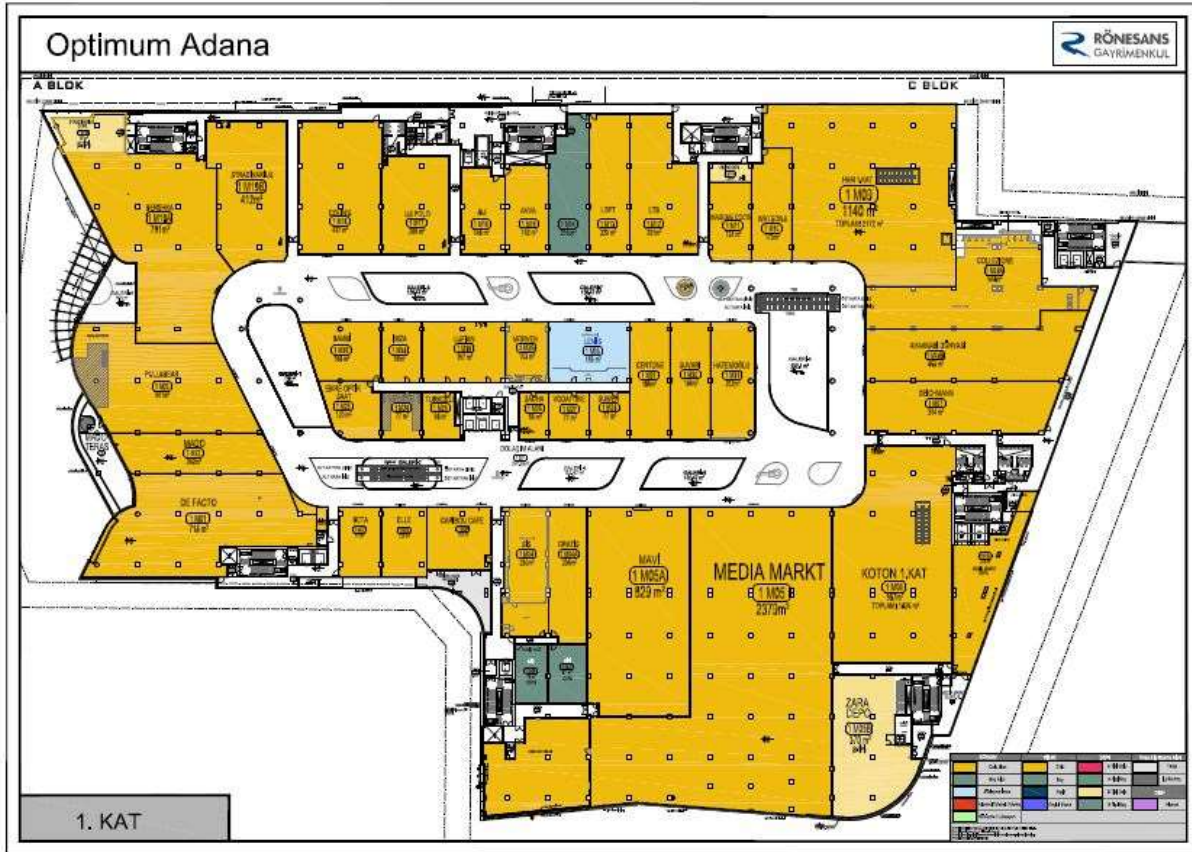
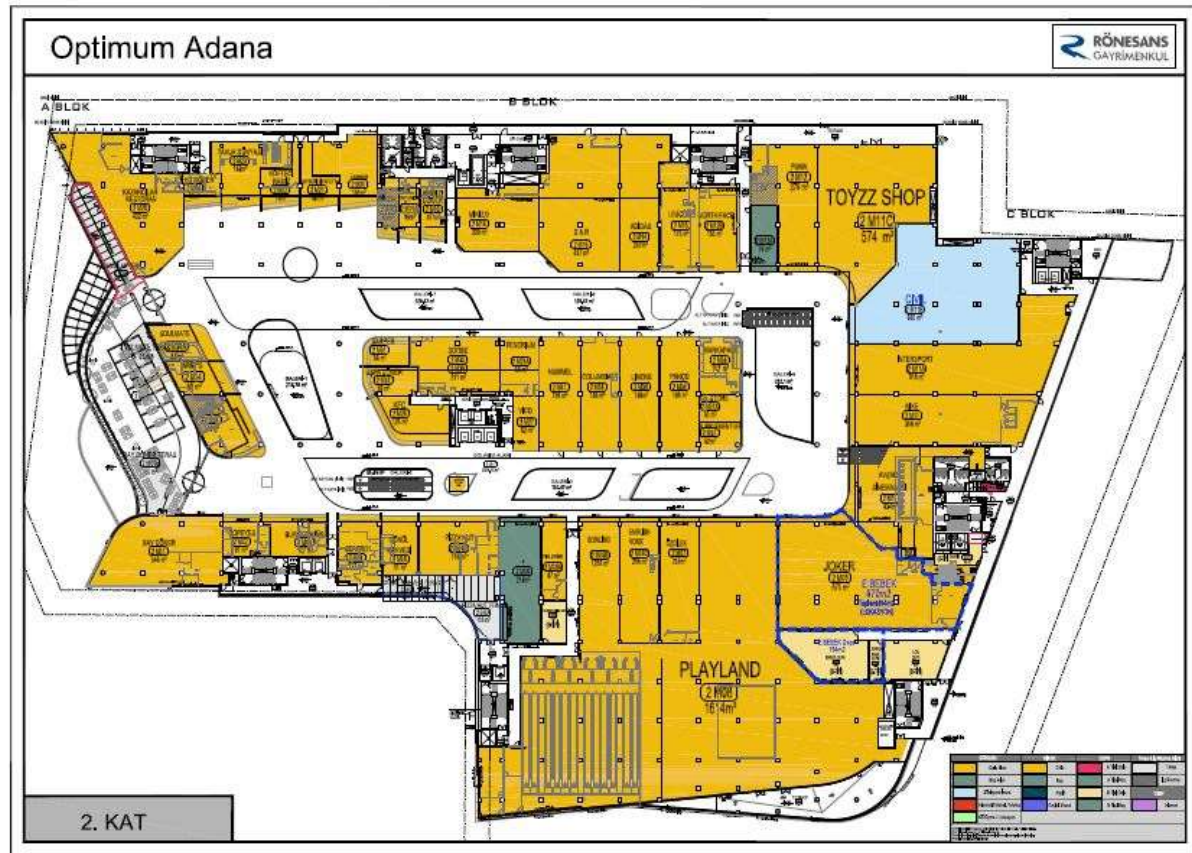
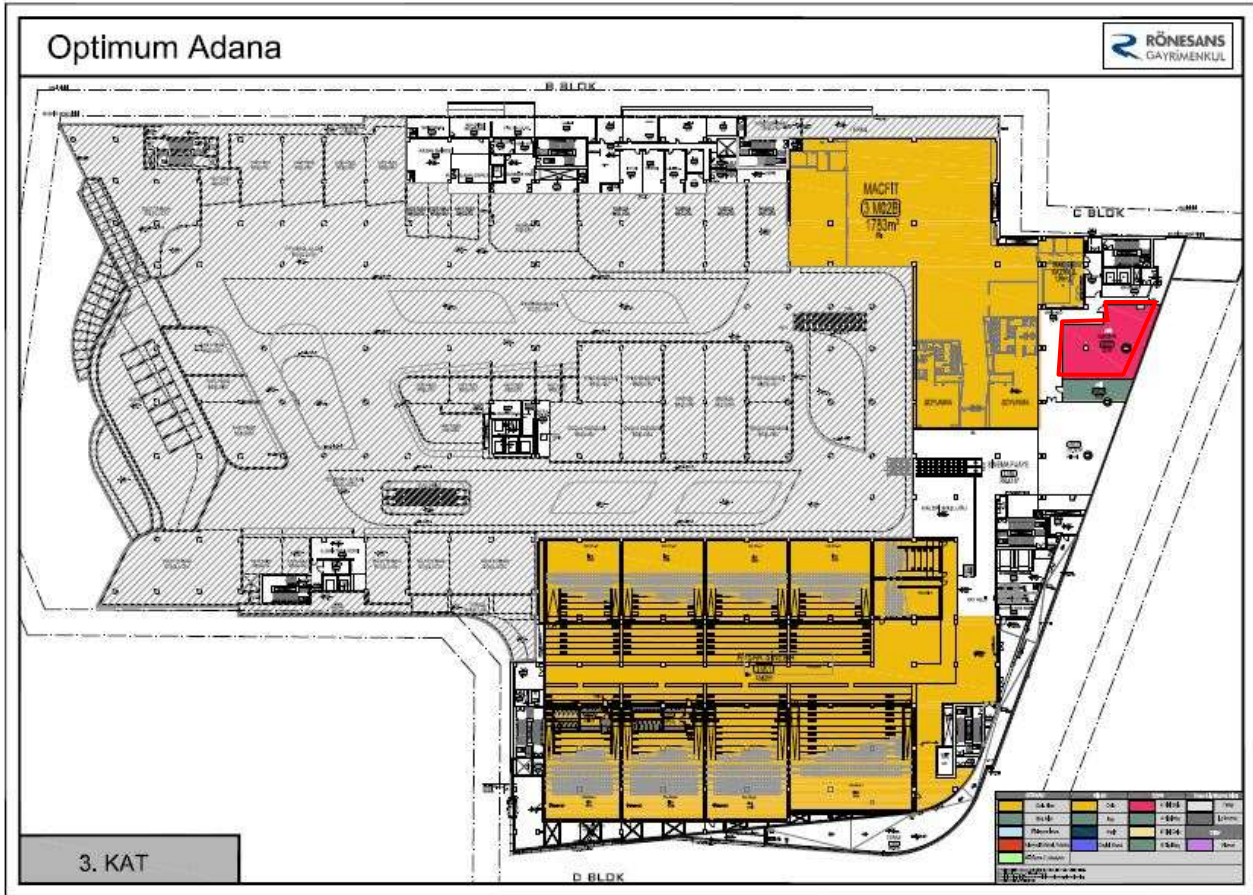
The parts highlighted in red on the floor plans below, which are designated as technical areas and parking areas, are currently being used by tenants, despite their original intention. The Shopping Center has an occupancy rate of approximately 99%.

Currently, 6,736 sq m of the 7,434.00 sq m hypermarket area located on the 1st basement floor of the main property has been converted into a parking area. This situation reduces the leasable area of the shopping center.

*In the approved architectural project of the property, the area of the hypermarket on the 1st basement floor (7.434 sq m) is currently being used as a parking area (6.736 sq m). Therefore, the leasable area provided by the client, which is 59.290,51 sq m, has been taken into account.

- Despite being centrally located, Yüreğir district is preferred by the lower income groups.
- It has been observed that contrary to the approved architectural project, some shops have been combined or divided, and certain volumes designated for parking or circulation areas have been converted into shops or warehouses and made available for tenants' use.
- The hypermarket area on the 1st basement floor of the shopping center, which has an area of 7.434,00 sq m, has been converted into a parking area of 6,736 sq m in its current state. This situation reduces the leasable area of the shopping center.
