Real Estate Optimum Outlet and Entertainment Center

Appraisal Etimesgut / Ankara

Report 2024REVB609 / 20.02.2025

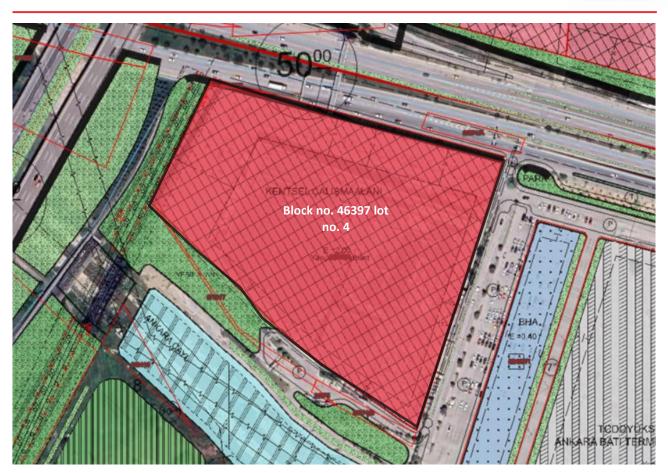
**Plan Name:** 1/1.000 scale "Ankara province, Etimesgut district, Eryaman block no. 46397, lot no. 4 Implementation Plan Change Amendment"

Legend: Urban Workspace

- Ground FAR: 2,00,
- H<sub>max</sub>: Unlimited,
- Towing distances: 30 m from the 50 m main transportation artery side, 45 m from the west of the parcel and 10 m from each of the other order.

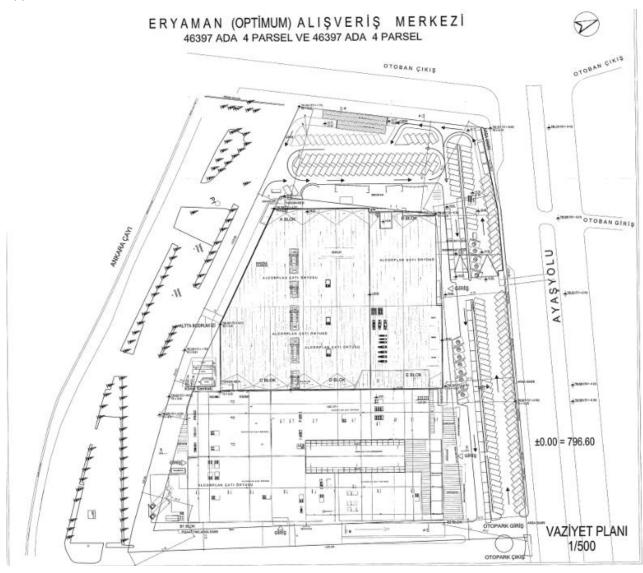
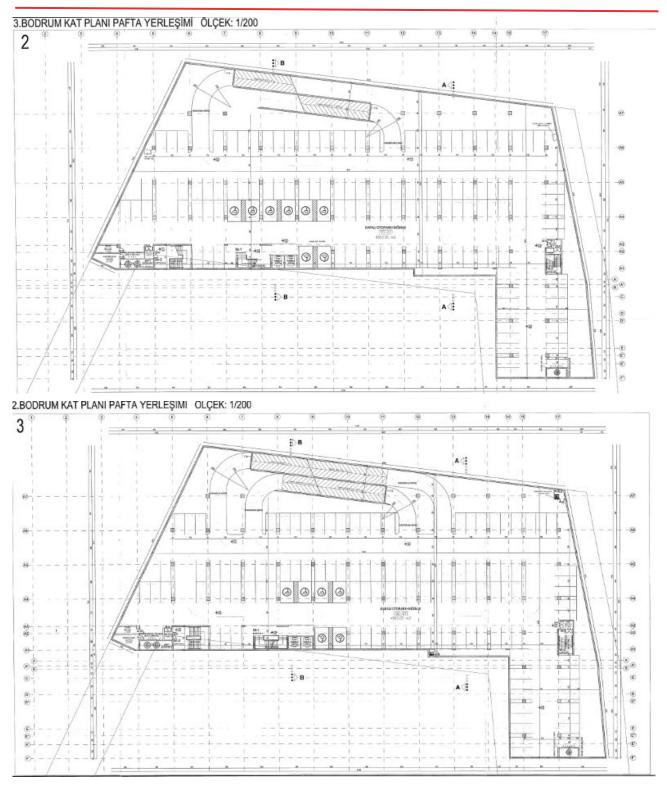
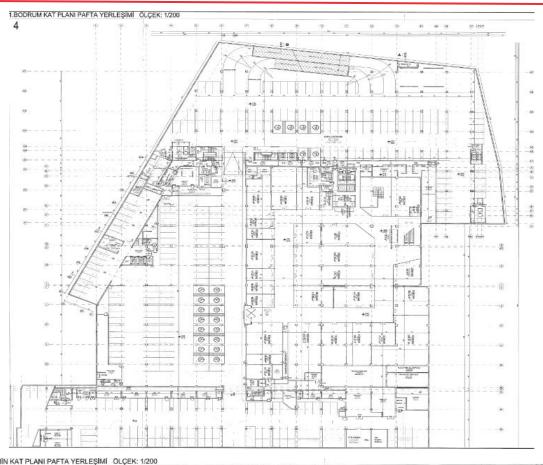
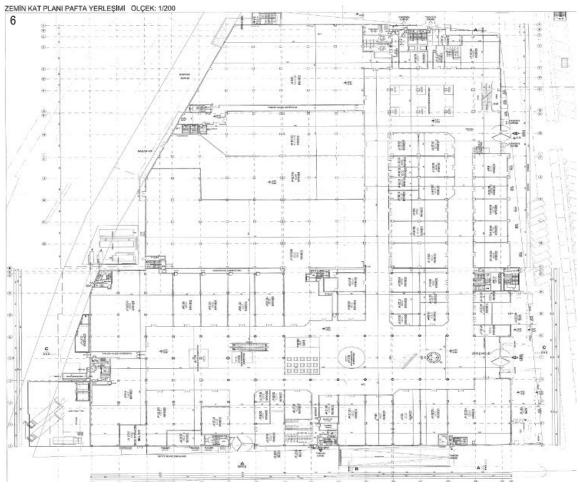
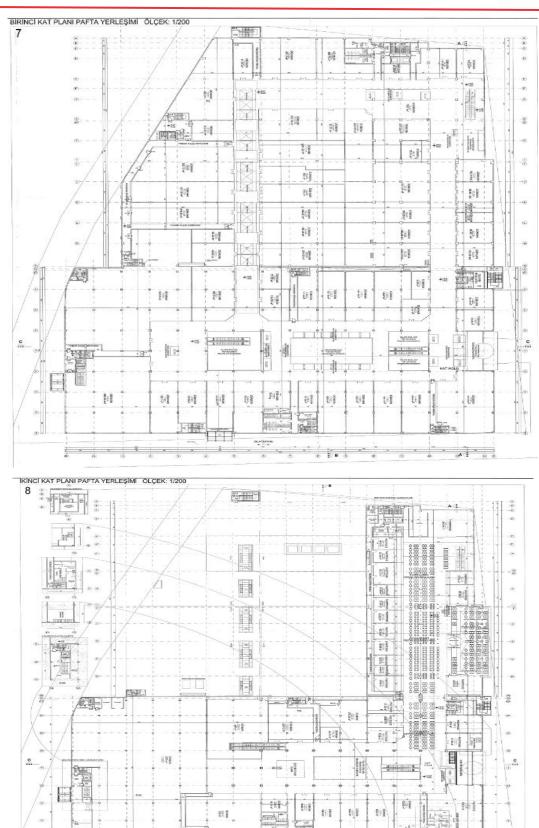
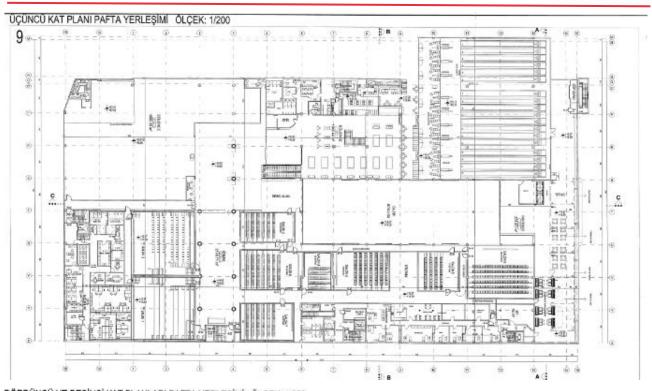
The layout plan and floor plans of the Shopping Center according to the renovation architectural project approved on 22.01.2019 are shown below.

According to the renovation architectural project of the real estate subject to appraisal, approved on 22.01.2016, there is a reduction in some leasable areas; It has been observed that some leasable areas have experienced growth. During the discussions about the real estate, it was learned that its legal compliance was mandatory and accordingly, a renovation project was prepared and implemented. In addition, the field

names in the previously reviewed renovation architectural project with approval date of 20.11.2013 have also changed. In addition, a renovation project was received for the subject property on 15.10.2019. According to the 2019 renovation project, although the total construction area does not change, the total leasable area of the property decreases by 328 sq m.
